# THRILL RIDE

**Bearing reliability  
keeps big wheel turning**

## Bearing reliability keeps **big wheel** turning

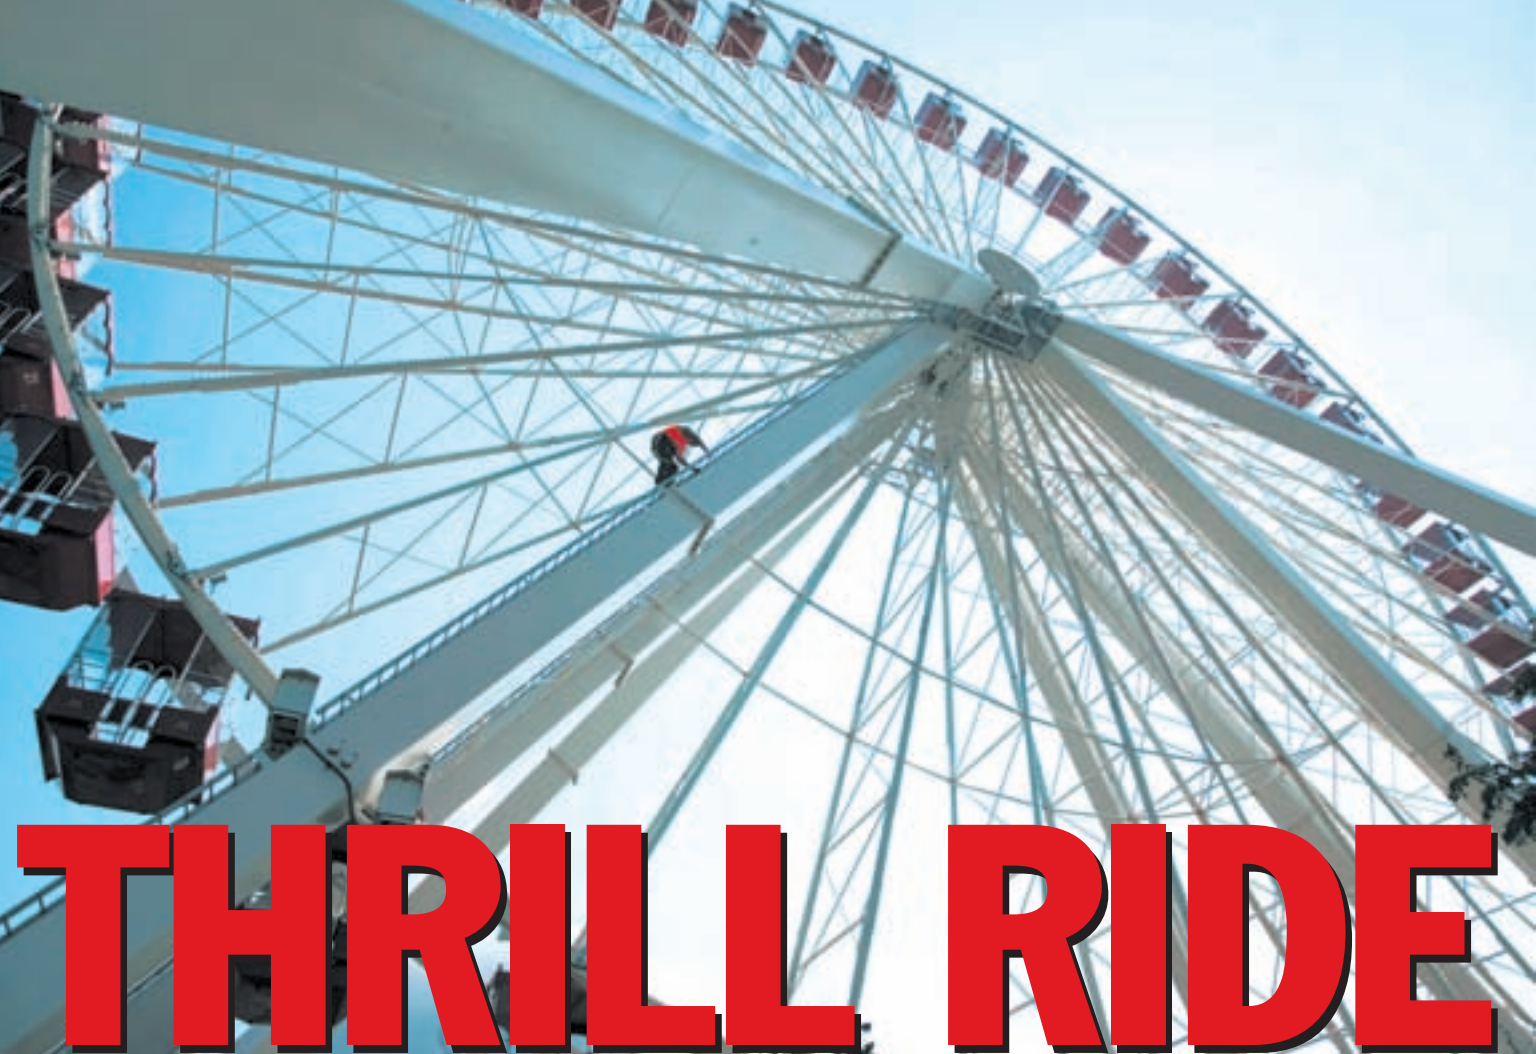
**ABOVE:** The wheel's bearings can only be reached by climbing a ladder to a platform located 75 feet off the ground.

The Ferris wheel is the Navy Pier's centerpiece attraction and can be seen from miles away. It's hard not to notice a big, slowly rotating wheel, two supporting pylon structures and two rather large bearings. Now take another look. The bearings are 75 feet off the ground, reached by climbing a ladder, and both are fully exposed to the prevailing winds and inclement outdoor weather.

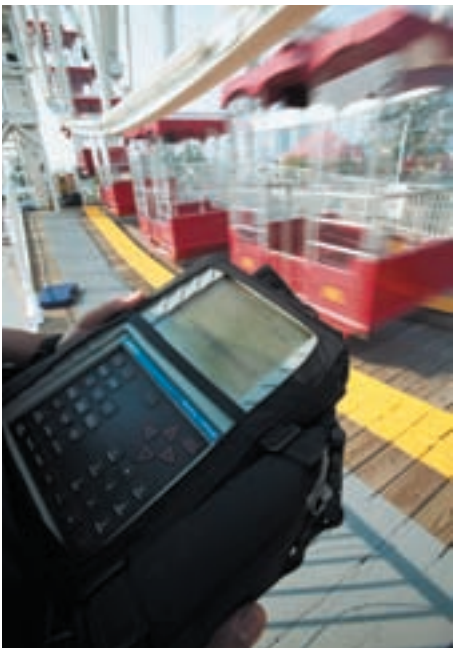
**LEFT:** Sensors attached to the wheel's bearings send vibration data to an SKF Microlog, where it's collected and analyzed.

After a detailed inspection of the Ferris wheel, SKF suggested a PM and PdM program be used that was based on routine vibration testing and grease analysis. For vibration testing, two 500 millivolt per G accelerometers were permanently attached to each bearing housing. The arrangement on the bearings was the same—one accelerator in the horizontal direction and the other vertical.

Wires were attached to the accelerometers by a Navy Pier technician and lowered to the ground where they were plugged into a portable SKF CMV60 Microlog data collector/analyzer. Having the accelerometers mounted permanently rather than magnetically gave an improved dynamic range, which enabled the collected data to be analyzed by SKF technicians.

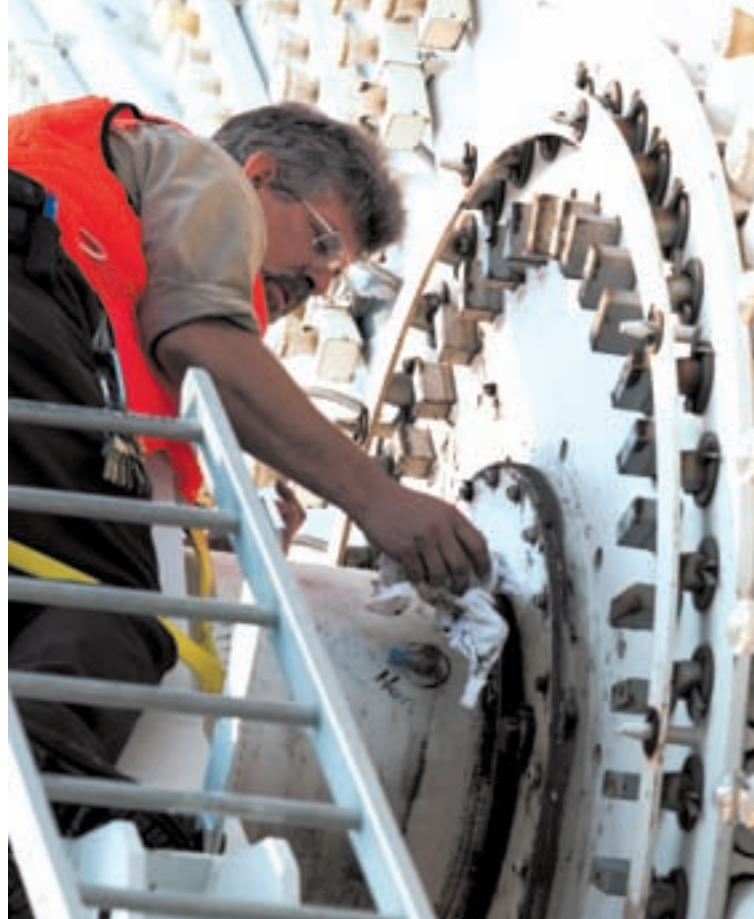
**The size and location of the bearing makes maintenance planning an absolute necessity for the Navy Pier team. If bearing replacement is eventually needed, the wheel must be disassembled. This puts it out of operation for several months.**
